Wattles Boys and Girls Club

Project Summary

Project in Brief

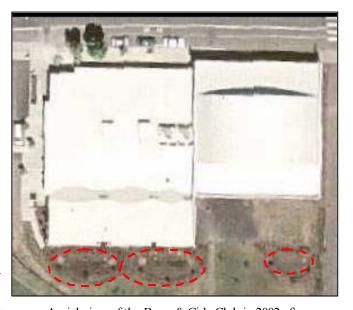
Aerial view of the Boys & Girls Club in 2002 after completion of the project. North is at the top of the image; the patio planters are visible on the west side of the building and the landscape infiltration basins are visible on the south side (circled in red)

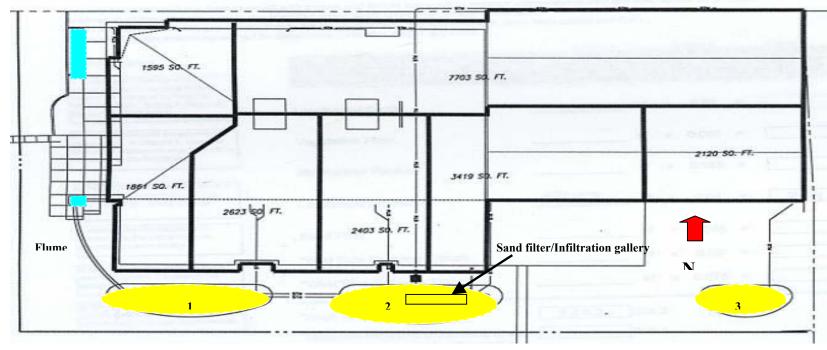
Site Plan of the Wattle's Boys and Girls Club indicating stormwater facility locations and roof catchment areas.

- A total of 3,500 sq. ft. of roof drains to two infiltration planters near the entrance; one overflows to a small drywell within the planter and the second overflows through a sculpted concrete trench ("flume") to linked landscaped infiltration basins.
- There are three landscape infiltration basins along the south side of the building.
 - The western infiltration basin receives runoff from the planter near the entrance and from adjacent roof areas. It overflows into the middle basin. The two linked basins receive runoff from a total of 10,300 sq. ft. of roof.

- o The eastern infiltration basin receives runoff from 2,100 sq. ft. of roof; overflow is directed to a small drywell.
- Runoff from about 7,700 sq. ft. of roof on the north side of the building is piped under the building to a combination sand filter/infiltration gallery, which also acts as an emergency overflow for the linked infiltration basins.
